3 watershed inventory and analysis

3.01 INTRODUCTION

In June of 2008, the project planning team conducted a stream inventory of the Duck Creek main stem to assess its condition and characteristics. Left and right bank are oriented as one looks downstream. Duck Creek exhibits a condition fairly typical of a Midwestern stream impacted by land use changing from natural to agricultural to urban and suburban. Many of the creeks problems can be attributed to the impact of this land use change on the flow and

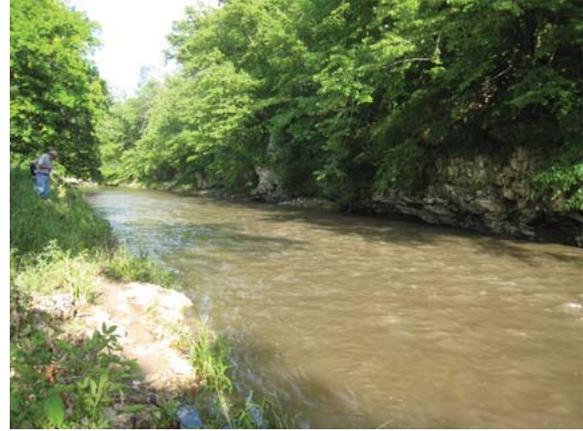
DW 2: the lower reaches of Duck Creek exhibited moderate habitat quality and healthy substrates.

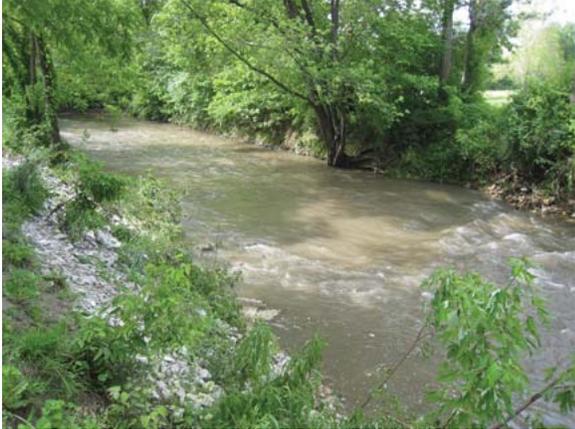
DW 7: Duck Creek within the Duck Creek Golf Course exhibited signs of erosion as well as some pools and riffles.

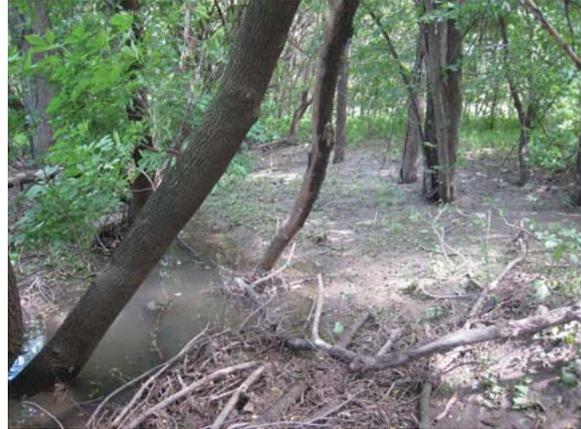
DW 9: heavy sediment deposition in the riparian corridor significantly impairs habitat and vegetative quality.

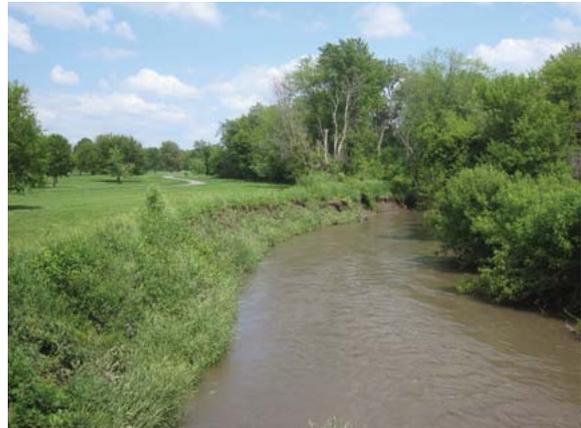
DW 9: significant bank erosion and slumping, and a very narrow native riparian corridor on the left bank of Duck Creek.

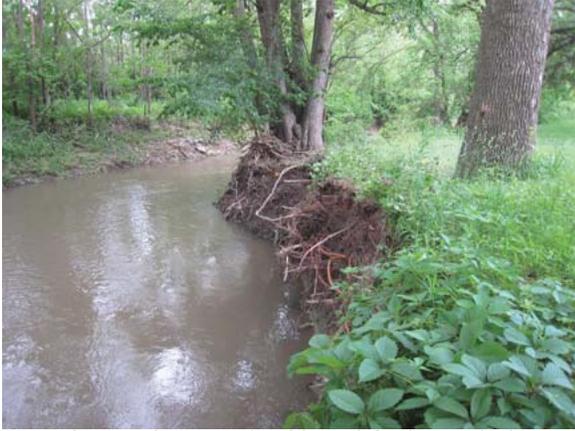
DW 10: Severe and recent erosion of the Duck Creek stream banks.

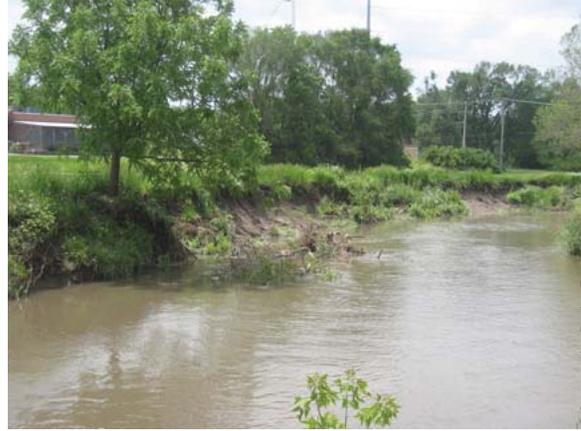
DW 11: severe bank erosion and slumping near Brady Street.

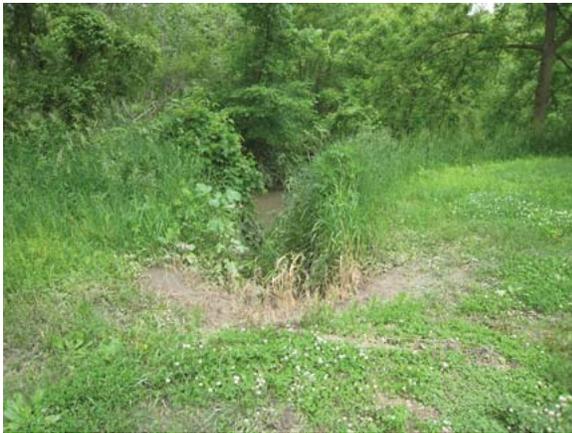
DW 10: gully erosion forms when flood waters flow back into Duck Creek.

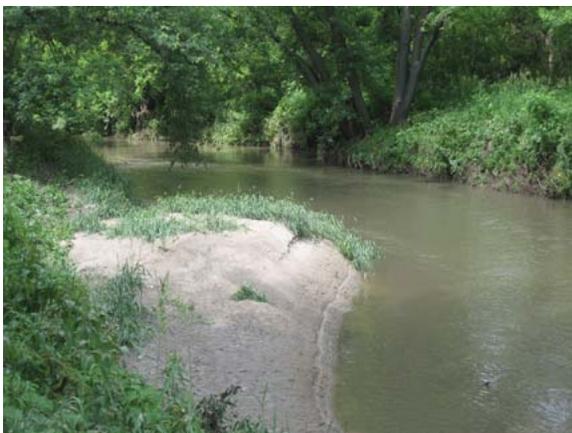
DW 10: heavy sediment deposition indicates movement of significant volumes of sediment from upstream to downstream.

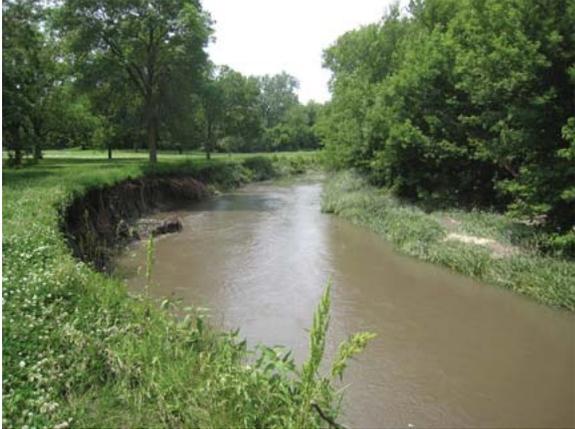
The creek here has highly unstable banks that display recent, active erosion and bank slumping, evident in the presence of exposed fine roots and freshly exposed dirt. While some vegetation was found on the banks, they are primarily bare and exposed except where banks that have previously fallen into the creek support vegetative growth. The inner bend of the creek shows sand, sedimentation, and the formation of point bars. These point bars force the stream to the other side, exacerbating bank erosion on the outside bend. Deposition on the inside and erosion of the outside bends indicate that lateral movement of the creek is occurring here. Floodwaters have deposited a layer of sand and silt within the riparian buffer area, and as floodwater flows back into

DW 12: severe erosion within Junge Park.

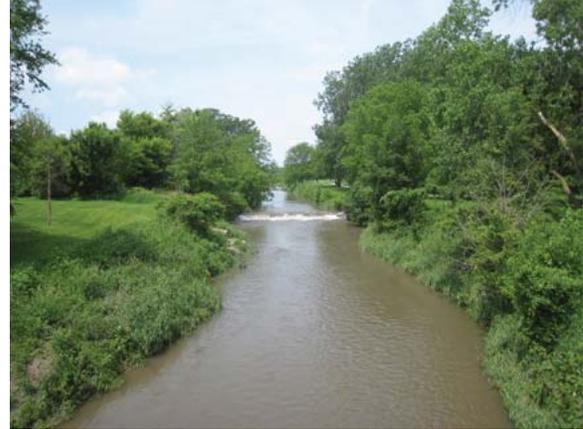
DW 13: one of the low head dams / sewer crossings on Duck Creek.

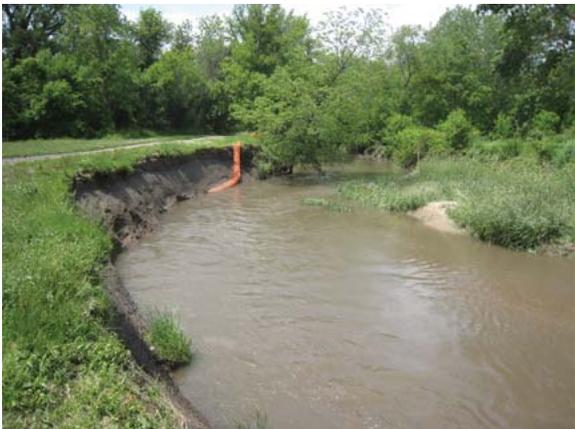
DW 12: severe erosion within Junge Park threatens the recreational trail.

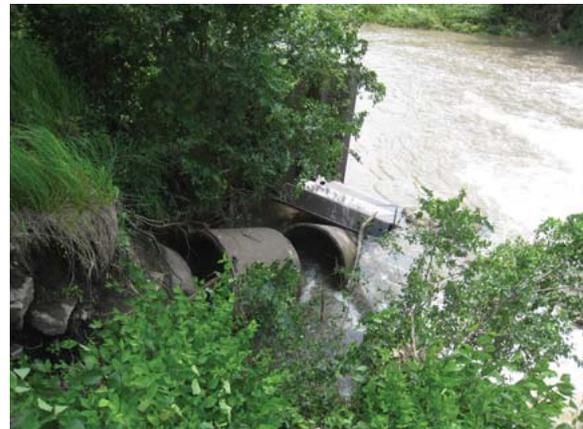
DW 13: stream bank erosion can cause the failure of stormwater infrastructure, requiring expensive repairs.

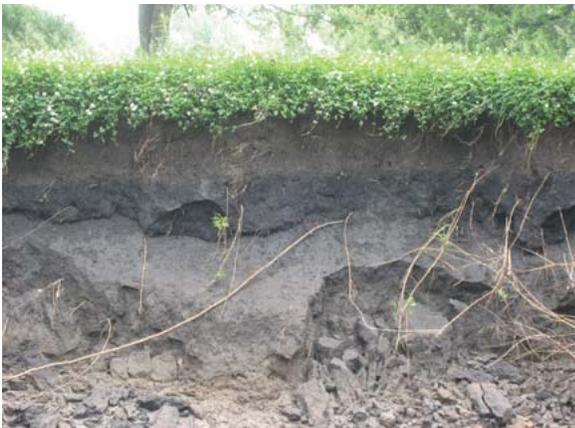
DW 12: turf grass does little to stabilize stream banks.

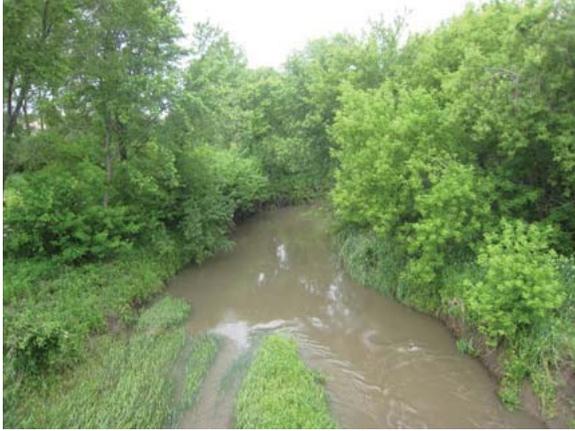
DW 16: some moderate stream braiding was observed along Duck Creek.

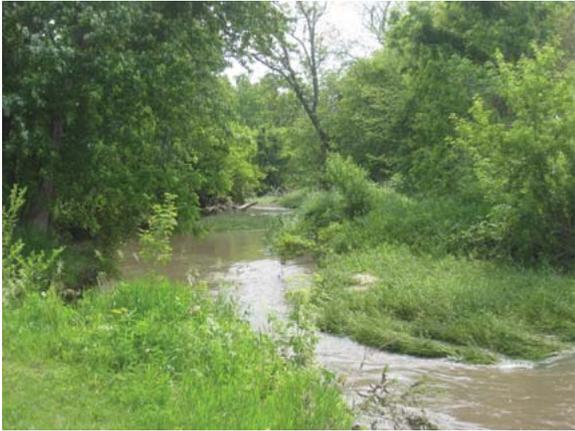
DW 15: moderate stream meandering and braiding were observed in upstream reaches.
